**A FLUVIAL GEOMORPHOLOGICAL STUDY OF
RIVER REHABILITATION IN THE KOUGA REGION,
EASTERN CAPE**

**Submitted in fulfilment of the
requirements for the degree of
MASTER OF SCIENCE
of Rhodes University**

January 2009

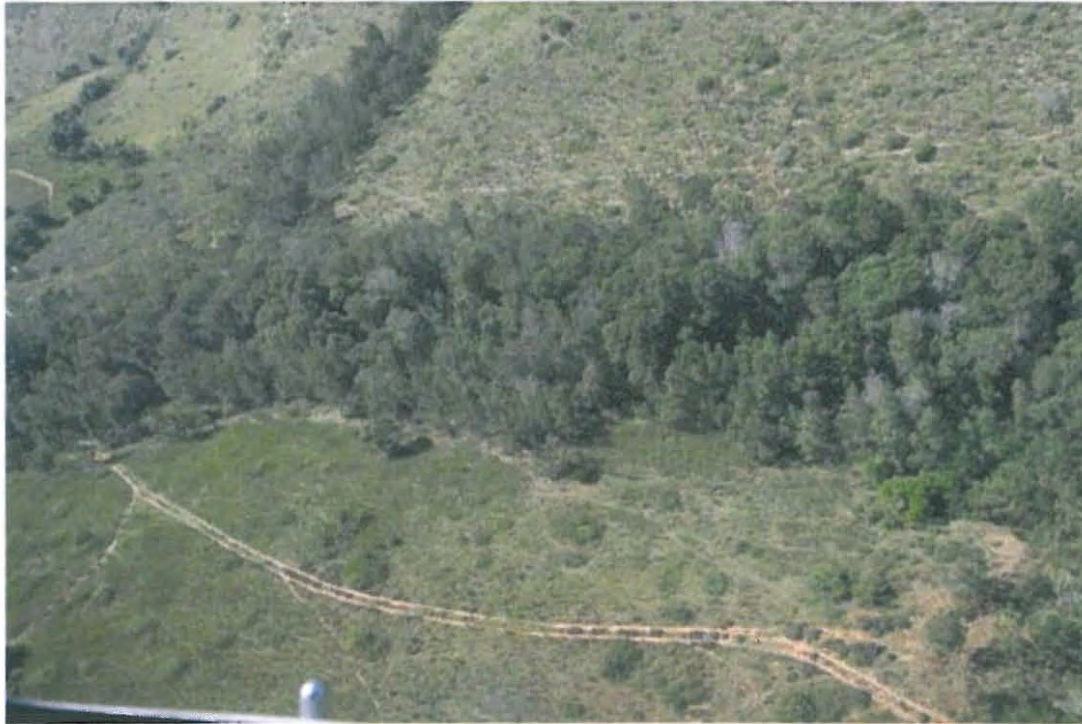
Plate 1 *Acacia mearnsii* infestation along the riparian zone of the Heuningnes River

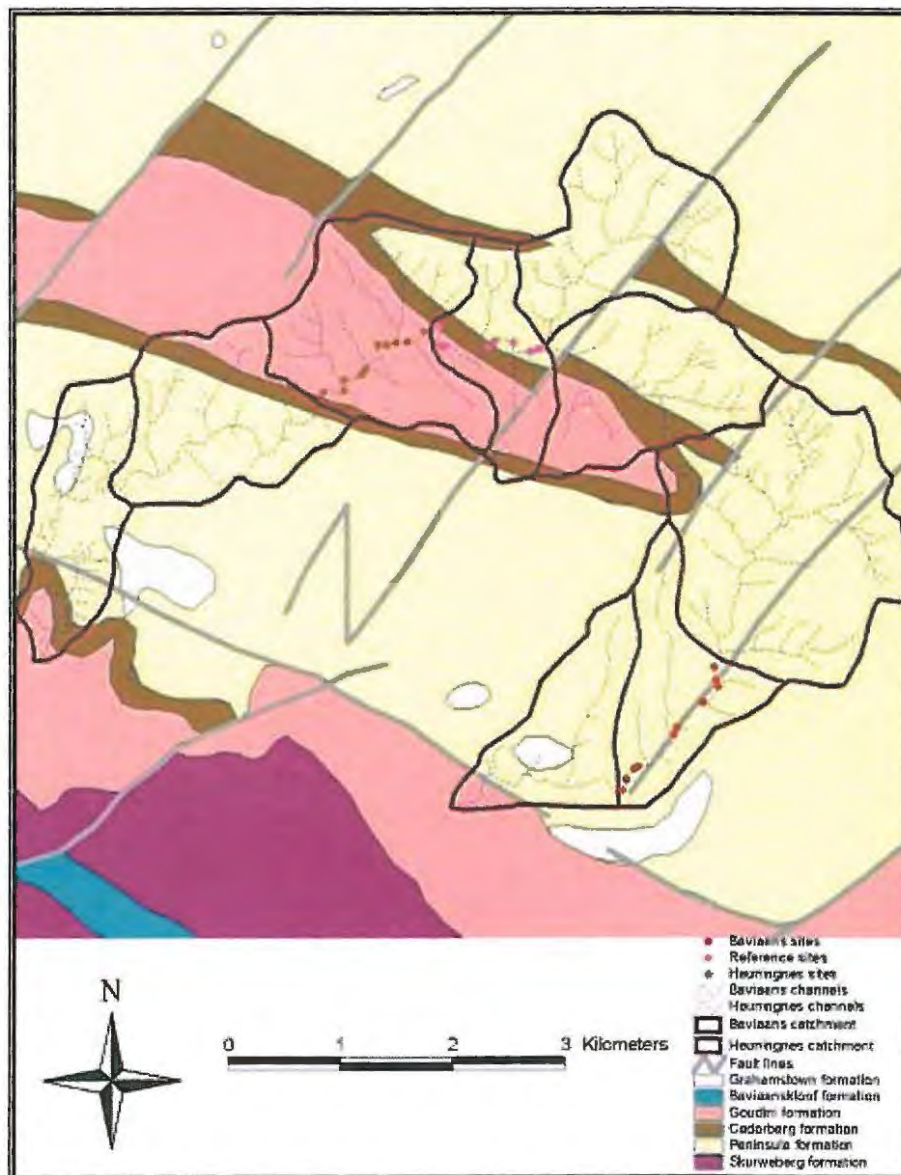
Figure 4.2 Geology of the study area (source: Chief directorate of surveys & mapping)

compressive stress resulting in a folded and partly thrustured Cape Fold Belt. A fault line runs underneath the Baviaans River channel in a north-easterly direction.

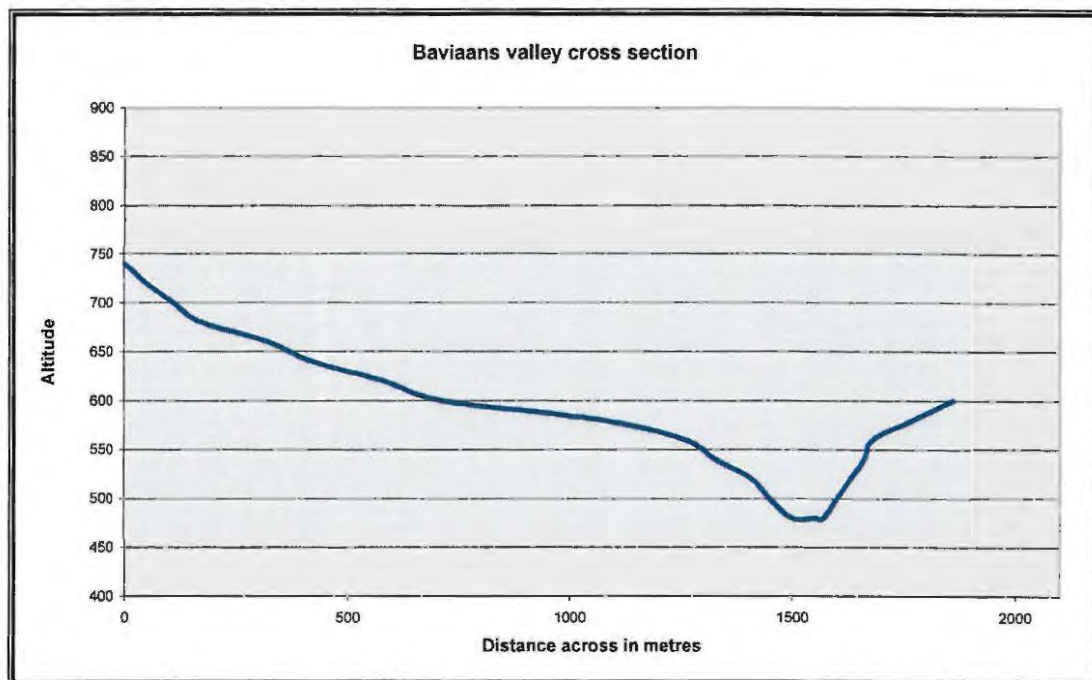
Figure 4.6 Valley cross-section of the Baviaans River facing upstream

catchment, the greater the significance of fluvial activity relative to hillslope activity. Secondly, wider floodplains or valley bottoms progressively buffer the channel from hillslope inputs. These two aspects have important consequences for the study catchments, since the Baviaans has a significantly narrower valley cross-section and steeper valley slopes in relation to Heuningnes and the Reference.

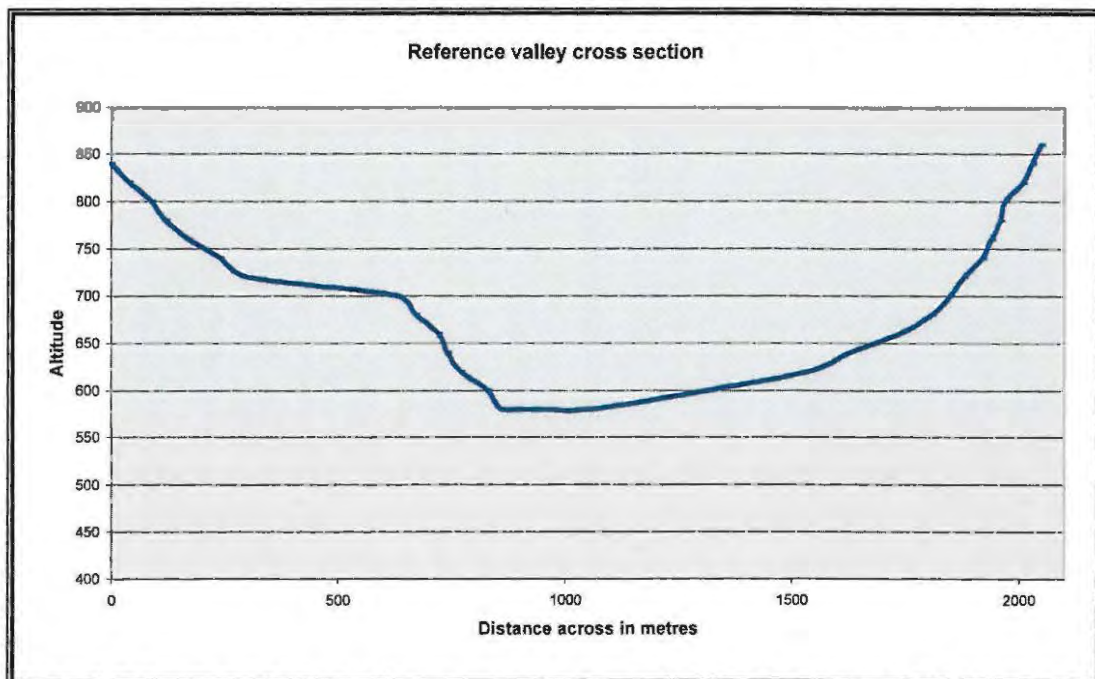
Figure 4.8 Valley cross-section of the Reference facing upstream

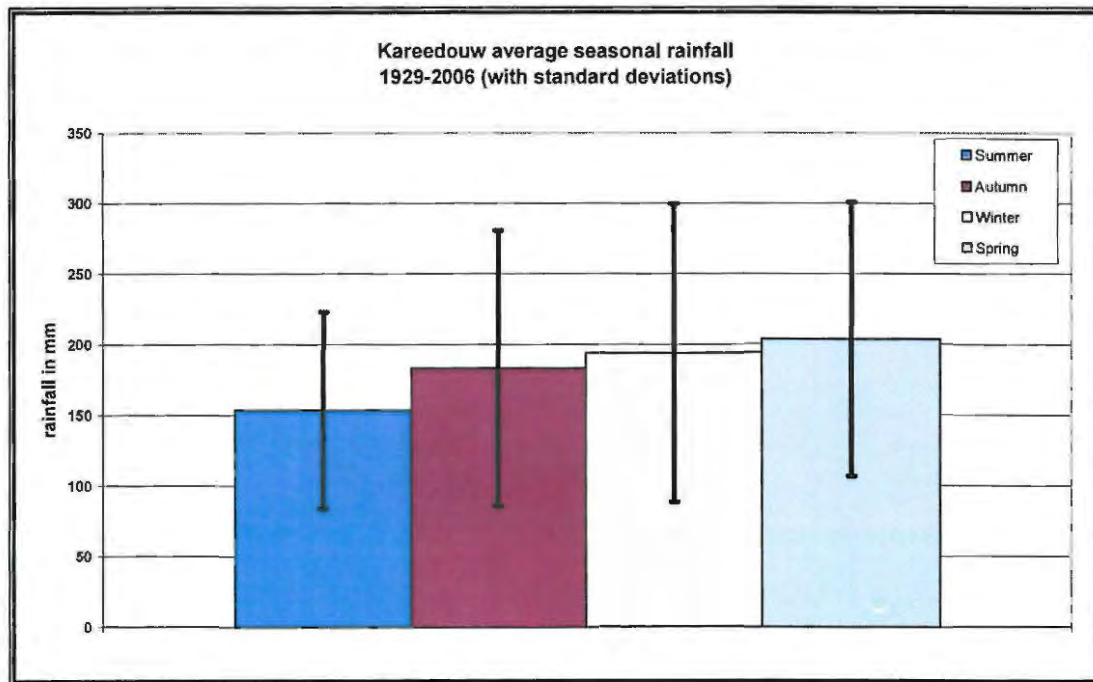
Figure 4.10 Kareedouw seasonal rainfall

The seasonality of the rainfall has obvious impacts on the indigenous riparian vegetation e.g. water availability and the competition for water with invasive woody species. Figure 4.11 shows the closest available daily evaporation data from the Kouga Dam which lies approximately 16km to the east of the study sites. It clearly shows the marked increase in evaporation rates over the hot summer months. Thus, the highest evaporation rates and least rainfall occur over these summer months. This will also have repercussions for the timing of re-vegetation and planting of indigenous flora to be carried out as part of the rehabilitation efforts of the KRRP.

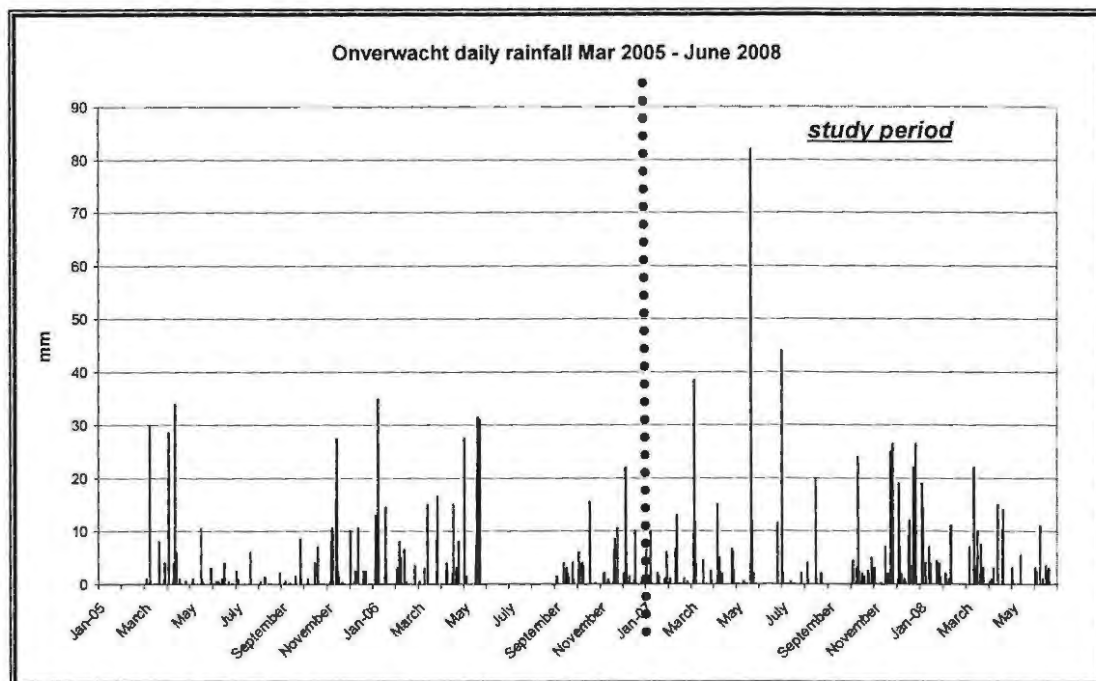
Figure 4.12 Onverwacht farm daily rainfall (source: Dept of Agriculture, Joubertina)

The study period for this thesis started in January 2007 and evidence of the 82mm that fell towards the end of May 2007 was still visible with a fieldtrip in early June. Figure 4.13 shows how good rainfall in May and December 2007 resulted in a total annual rainfall slightly above the 1993 - 2006 annual average. This is in contrast to the first half of 2008 with its lack of significant rainfall. Based on conditions during the many fieldtrips, the Onverwacht farm's daily rainfall data provides a good account of the rainfall conditions taking place within the study catchments.

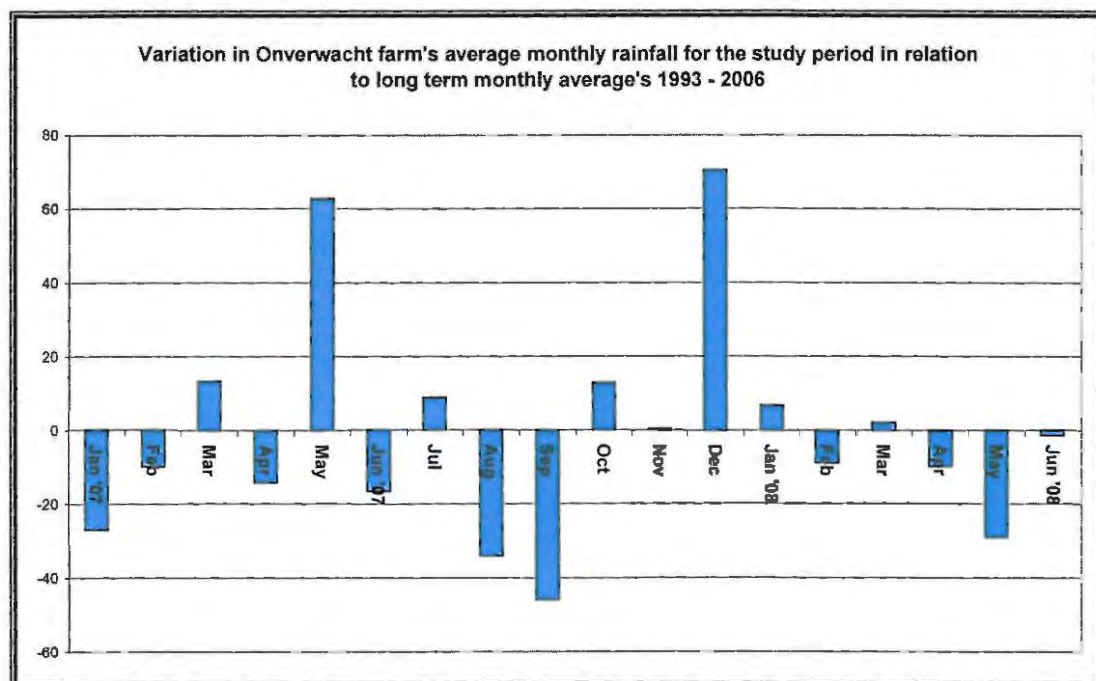
Figure 4.13 Onverwacht monthly rainfall variations for study period (source: Dept of Agriculture, Joubertina)

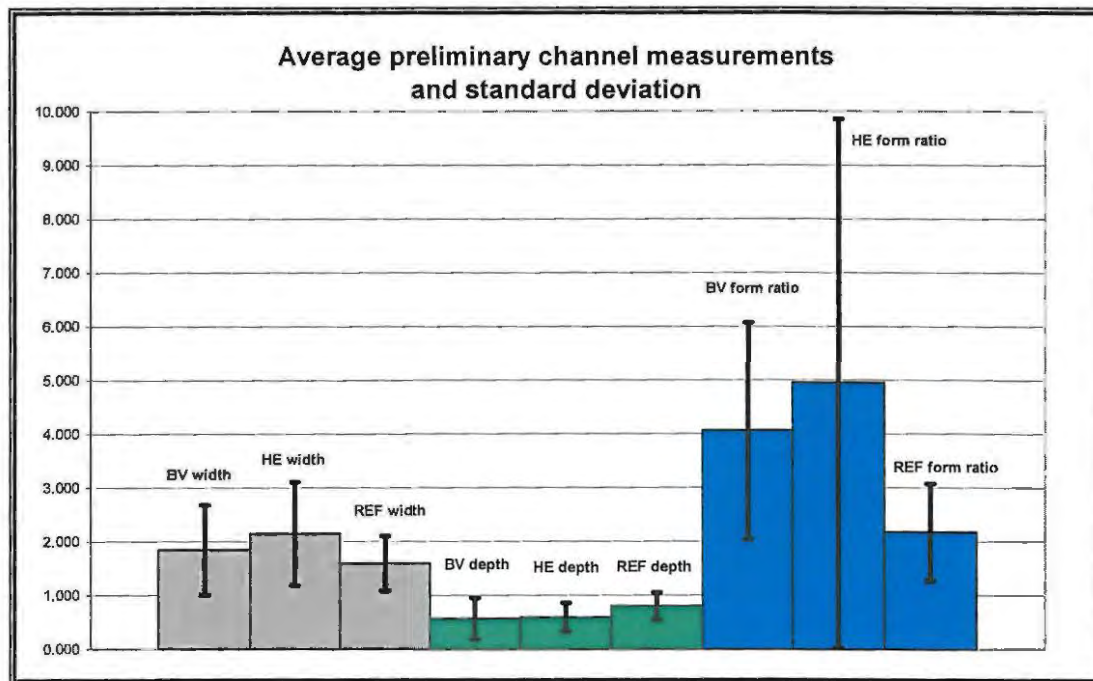
Figure 5.1 Preliminary assessments of channel measurements (width and depth in metres)

Figure 5.1 shows the results of the initial rapid assessment of channel measurements completed during the earlier reconnaissance fieldtrip to the study sites. It suggests a marked difference in channel form ratio (width-depth ratio) between the invaded Bavians and Heuningnes channels and the channels higher up the Heuningnes catchment considered as 'natural' at this stage.

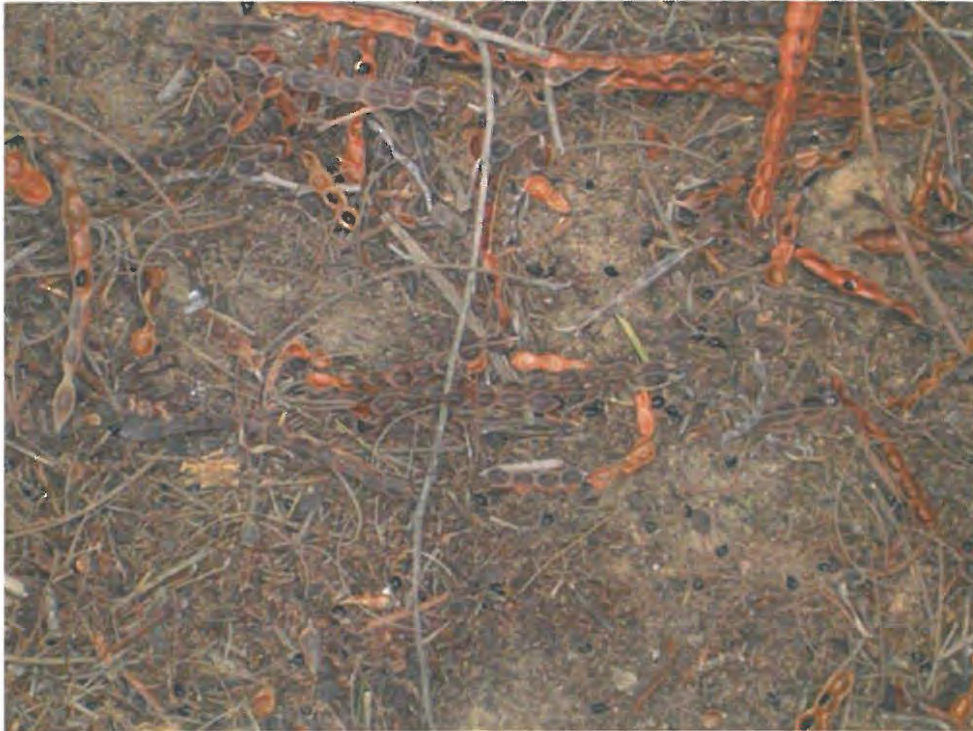
Plate 4 Close-up of barren terrace soil in the Heuningnes showing the plentiful supply of wattle seeds (Photo: Saskia Fourie)

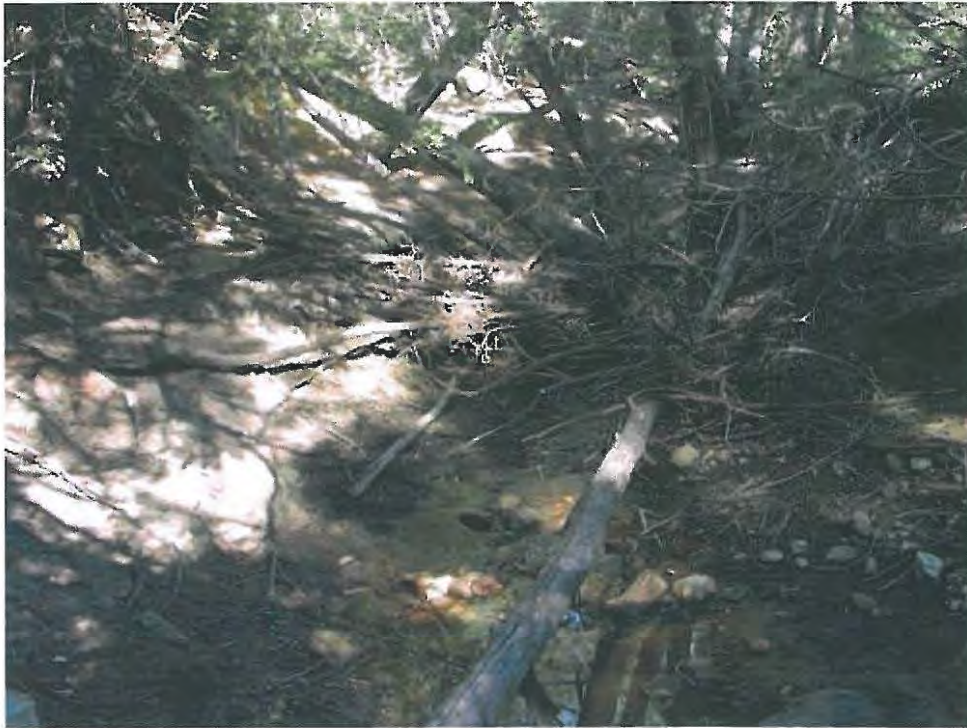
Plate 6 Collapsed wattles and other LWD in the study area (Photo: Kate Rowntree)

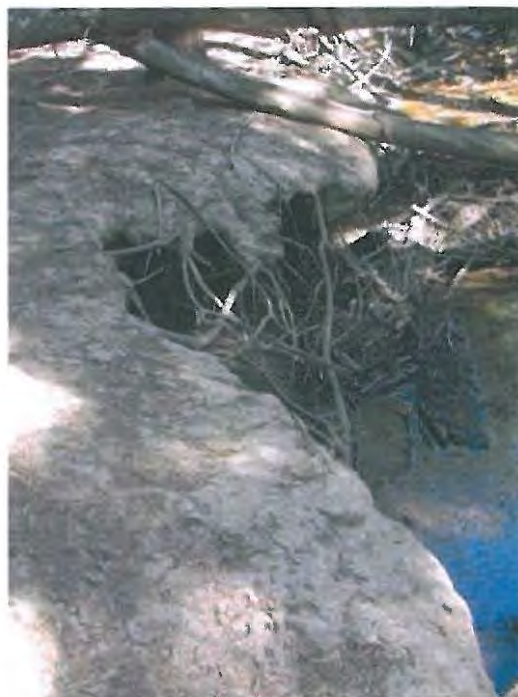
**Plate 7 Undercutting in the study area
(Photo: Kate Rowntree)**

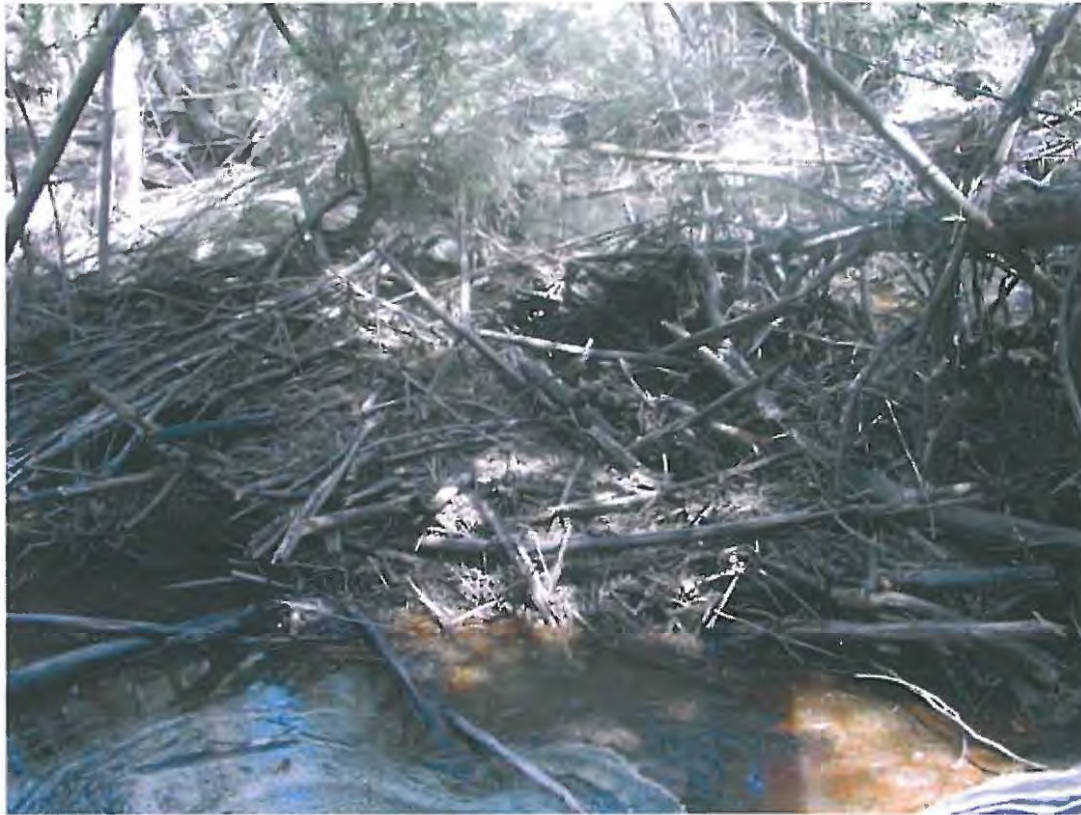
Plate 8 A debris dam in the Heuningnes (Photo: Kate Rowntree)

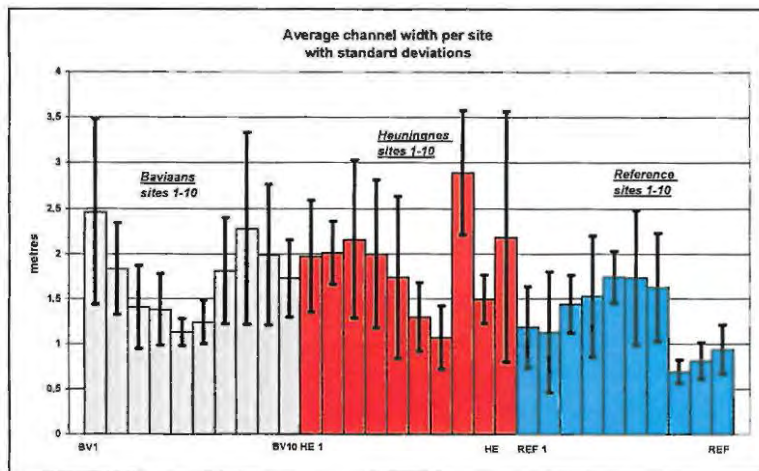
Figure 5.2 Average channel widths per site

While Figures 5.2 – 5.5 show the downstream trends of the four channel form variables being studied, Figure 5.9 emphasises the difference in channel form variables between each study reach based on all 50 cross-sections or transects (49 for Baviaans and Reference).

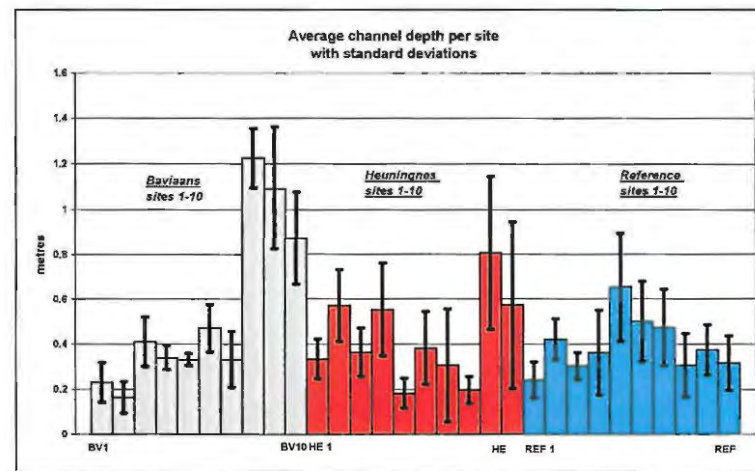
Figure 5.3 Average channel depths per site

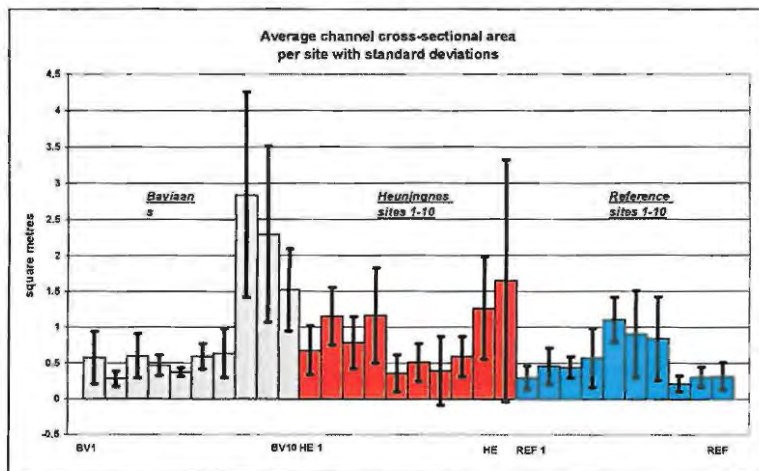
Figure 5.4 Average channel cross-sectional areas per site

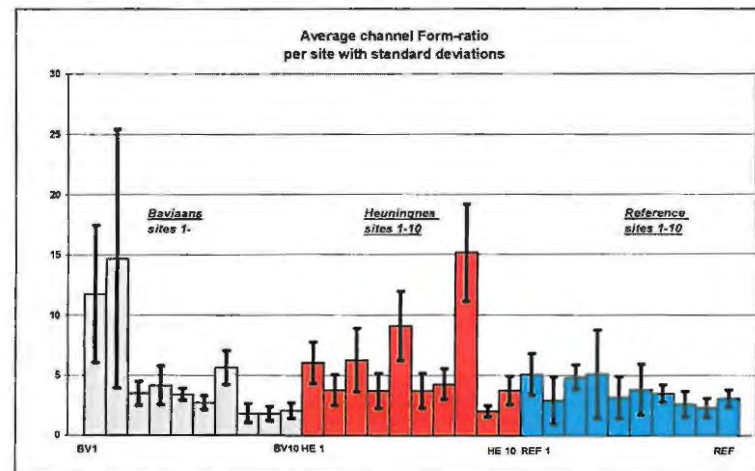
Figure 5.5 Average channel form ratios per site

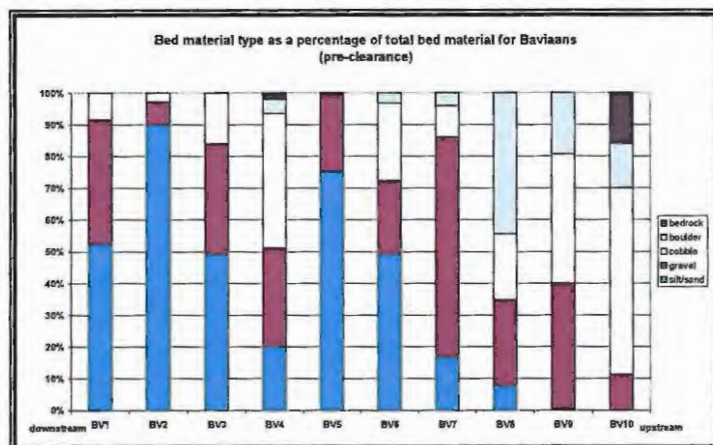
Figure 5.6 Baviaans bed material type per site

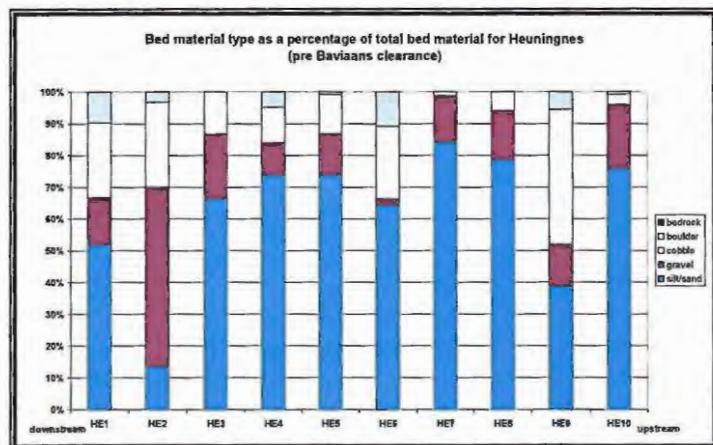
Figure 5.7 Heuningnes bed material type per site

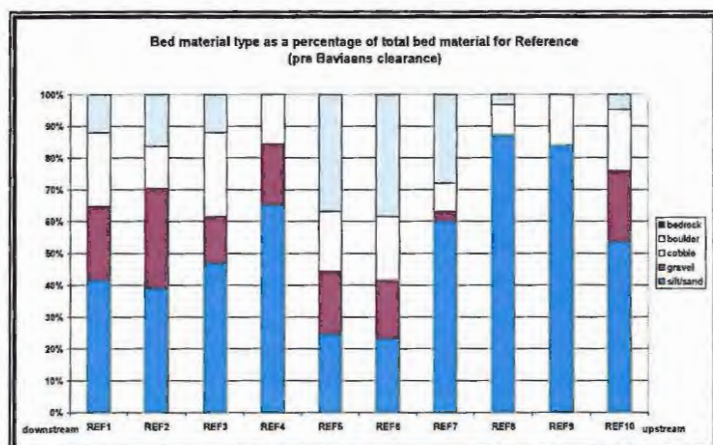
Figure 5.8 Reference bed material type per site

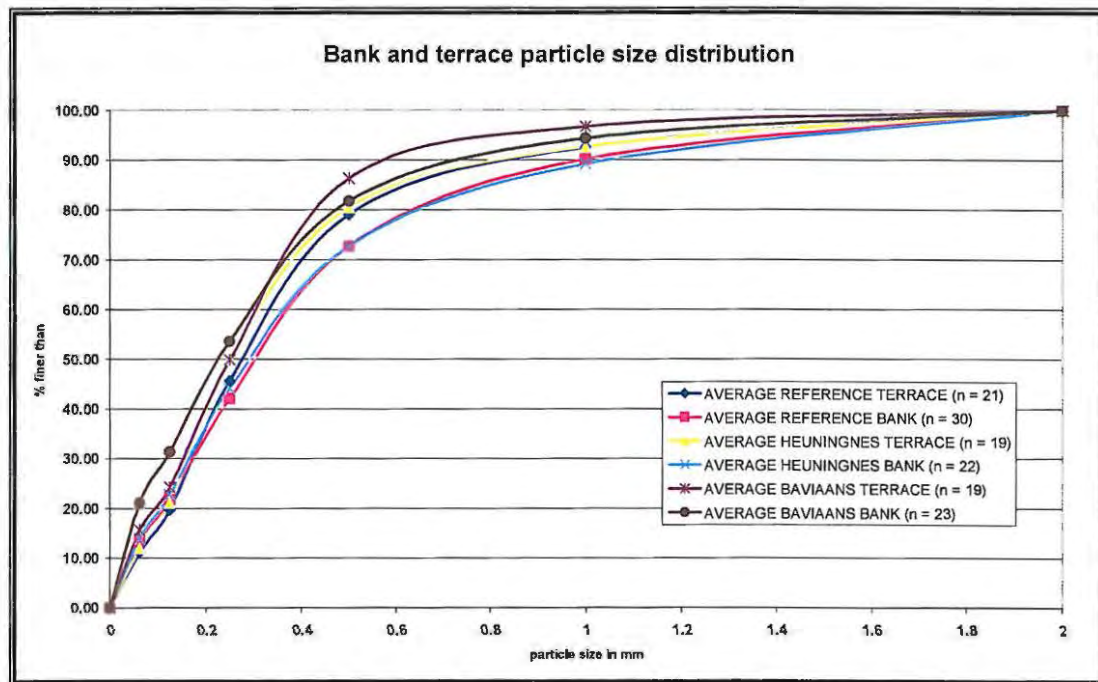
Figure 5.14 Bank and terrace particle size distribution

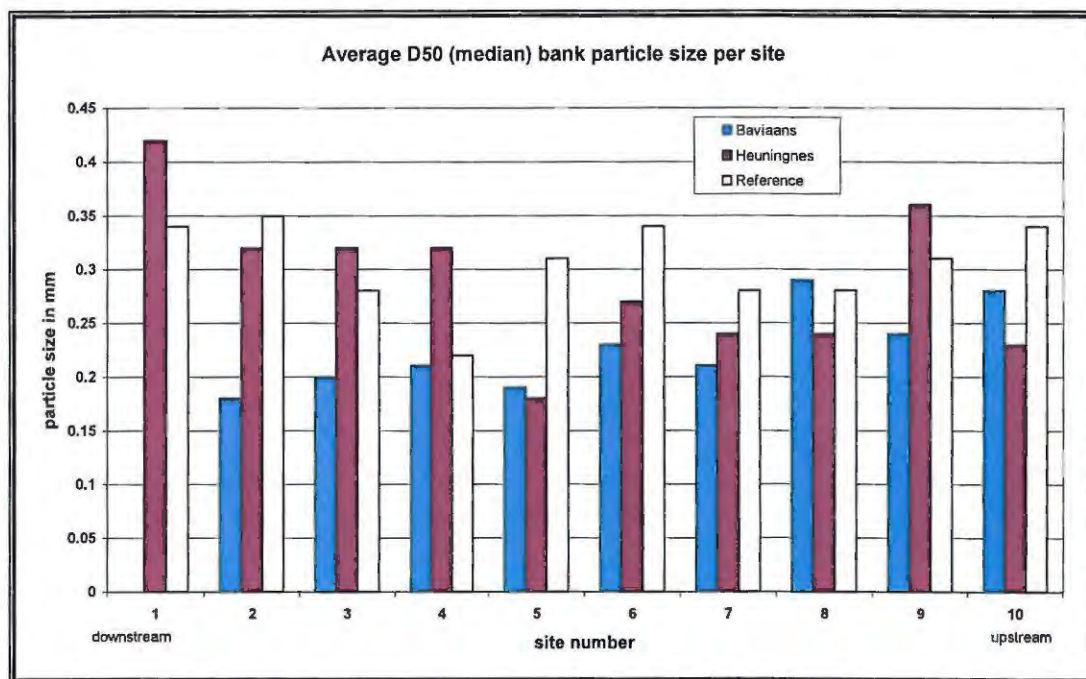
Figure 5.15 Average D50 (median) bank particle size per site

invaded reaches, Bavians has smaller bank particles and a higher percentage of silt/clay (see Figures 5.15 and 5.16). This will have an effect on bank cohesion and bank strength, especially considering the effect of alien wattles growing along the invaded channel banks. Appendix C provides all the data relating to bank and terrace material.

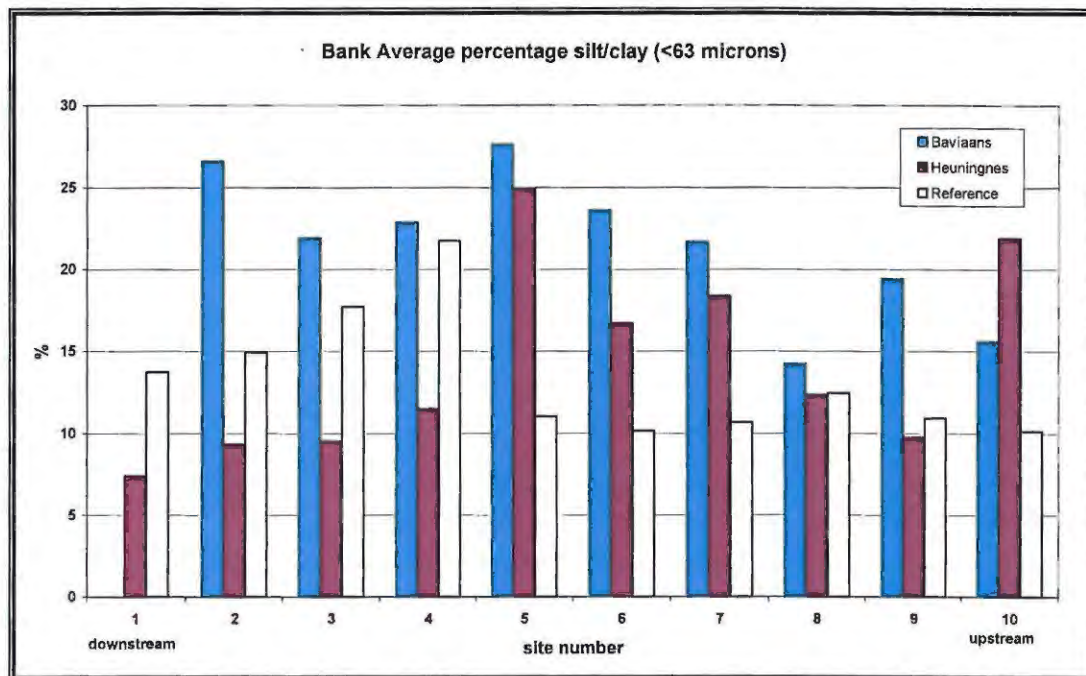
Figure 5.16 Average bank silt/clay content per site

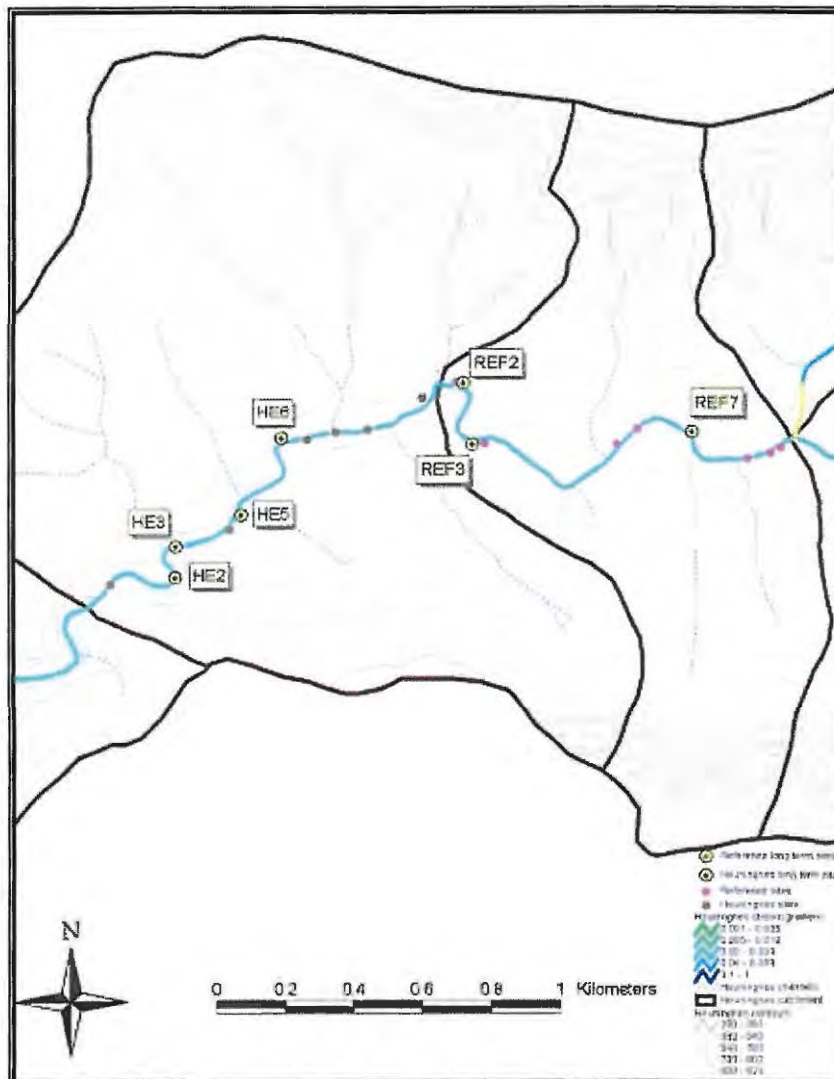
Figure 7.3 Location of Heuningnes and Reference long-term monitoring sites (key sites labelled)

Baviaans	BV8 , BV9 , BV10	BV3, BV4 , BV5, BV6, BV7	BV1, BV2	
Heuningnes	HE2 , HE4, HE9, HE10	HE6 , HE7	HE1, HE3	HE5 , HE8
Reference	REF5, REF6, REF7	REF2 , REF8, REF9, REF10	REF1, REF3 , REF4
